Beckfoot & Hazelbeck School - Accessibility Action Plan.

Updated: 10/01/2025

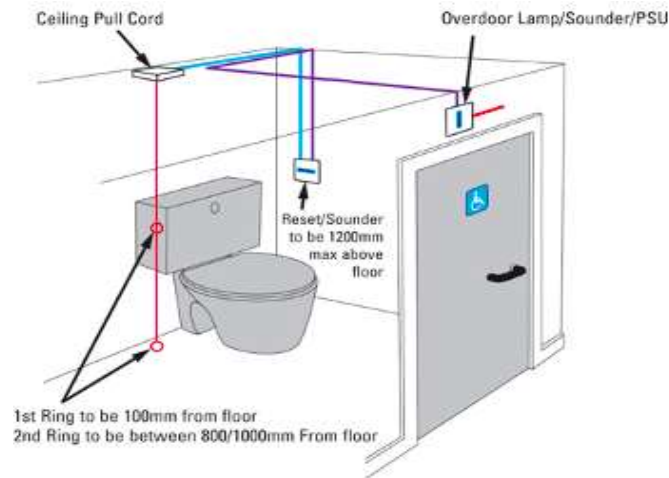
13.11

Cord alarms across the facilities were unsuitably positioned.

The cord alarms in HK 55C, HK57C, HK60.3, and HK60.2 were tied and not hanging within a suitable distance to the floor.

A broken cord alarm was identified in HK57B.

No cord alarm systems were identified in HK58B or HK58E.

Cord alarms in HK60.4 and HK57E were positioned behind items and could be difficult to access.

Should someone using these facilities required the cord alarms, but cannot reach them, their distress calls may go unnoticed.

According to BS8300 - An emergency assistance pull cord should be sited so that it can be operated from the WC and from an adjacent floor area. The emergency assistance pull cord, coloured red, should be provided with two red bangles of 50 mm diameter, one set at a height between 800 mm and 1000 mm and the other set at 100 mm above floor level.

Implement a management procedure to ensure that cord alarms are always kept loose and not tied up.

Utied - Amey to monitor on routine check
MJA to check
Hygeine rooms not requiring alarm
Students generally have supervision and no incidents in the last 12 years regarding these toilets. Teaching staff and support have access to all the student EHCP and would put in appropriate support

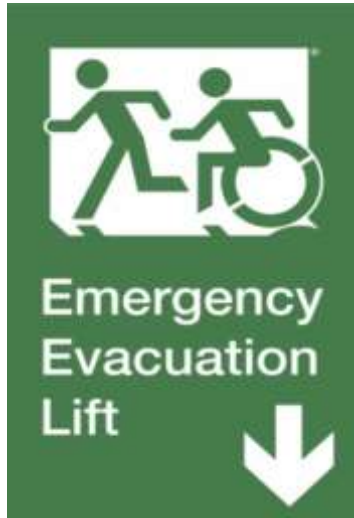
17.4

The auditor was informed that the lifts could be used in the event of a fire evacuation. The lifts featured signage that indicated that they could not. This could lead to confusion during an emergency evacuation.

BS9999: A lift to be used for the evacuation of disabled people should usually be either an evacuation lift or a firefighters lift, and should be operated under the control of the fire safety manager or a delegated representative, or otherwise by someone trained and authorized in the use of the lift. Evacuation lifts should be provided, constructed and operated in accordance with Annex G.

A lift that is not explicitly designed for evacuation may be used for evacuation, provided that it provides the same functionality as an evacuation lift. If this is to be considered as an option then a suitable risk assessment should be undertaken to evaluate whether the lift meets the recommendations given in Annex G: *lifts used as part of the evacuation sequence for persons with disability and persons requiring assistance, which has appropriate structural, electrical and fire protection and is capable of being taken under control by a trained and authorized person*

Should the lifts be suitable to use in the event of an evacuation, they should be clearly identified by appropriate Fire Safety sign and included

Signage has been placed on the lifts advising Haz trained staff able to use in a fire.

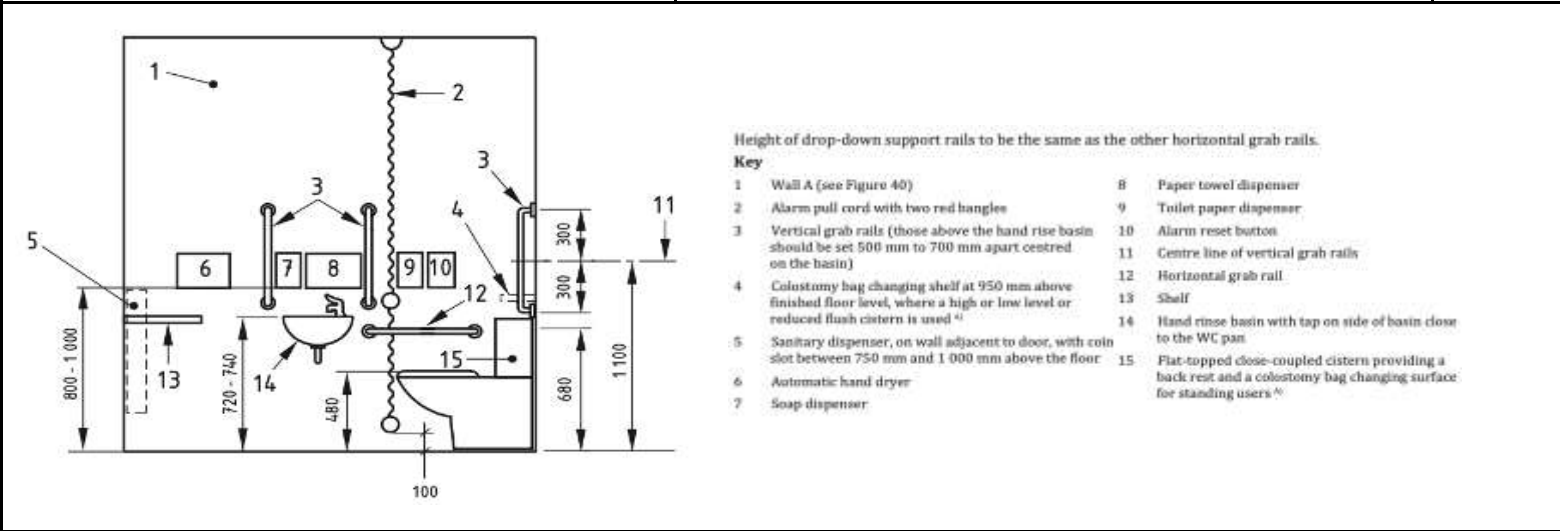
13.5

The soap dispenser was not provided at a height of approximately 1050mm in HK60.1.

The hand towel dispenser was high in HK57B, at approximately 1215mm.

There are fittings across the WC facilities that do not provide contrast against their surroundings as they are white against a light background.

The dispensers should be relocated at a height of between 800mm and 1000mm above finished floor level., as indicated by BS8300 Figure 42.

Greater contrast should be considered for the fixtures and fittings within the WCs. This can be achieved by having light sanitary ware seen against a dark background or vice versa.

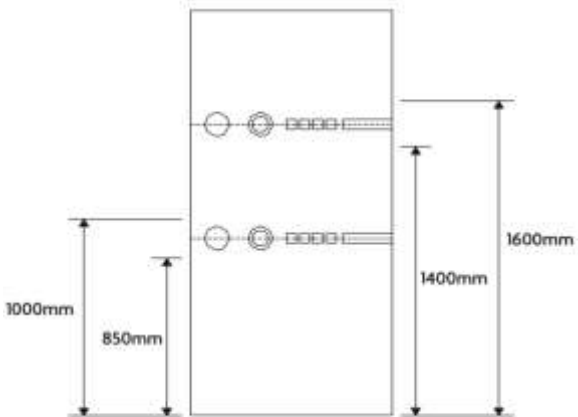
<p>5.9</p>	<p>The glazed doors did not feature manifestations at two heights, to assist with reducing the risk of a collision.</p>	<p>All full height glazed areas must be clearly highlighted with manifestation that contrasts visually with the surface behind it under both natural and artificial lighting conditions, from all likely viewing directions. This manifestation should be located within two zones, from 850mm to 1000mm from the floor and from 1400mm to 1600mm from the floor.</p>

<p>1000mm 850mm 1400mm 1600mm</p> <p>Manifestation can take various forms, e.g. broken or solid lines, patterns or company logos</p>	<p>M</p>	<p>Change notice ask for two heights of stickers on the door.</p>
<p>6.7</p>	<p>No signage was identified to state that information could be provided in alternative, accessible formats when required.</p>	<p>It is recommended that signage be installed to indicate that all public information issued can be provided in accessible formats on request. Refer to 15.7.</p>	<p>N</p>

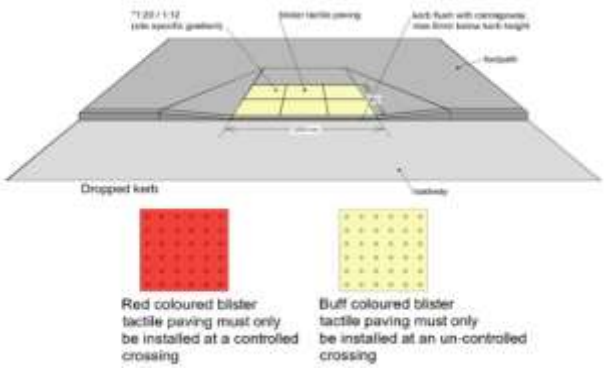
<p>1.2</p>	<p>Crossing points on approach to the school featured dropped kerbs and tactile paving.</p> <p>The crossing point next to the car gates and intercom systems featured slightly damaged tactile paving, which could cause confusion for people who are partially sighted.</p> <p>The crossing next to the main, school gates was faded and requires remarking.</p>	<p>Site management to schedule repair of the tactile paving to replace the broken areas.</p> <p>The crossing point requires remarking to ensure that it is clearly distinguishable.</p>

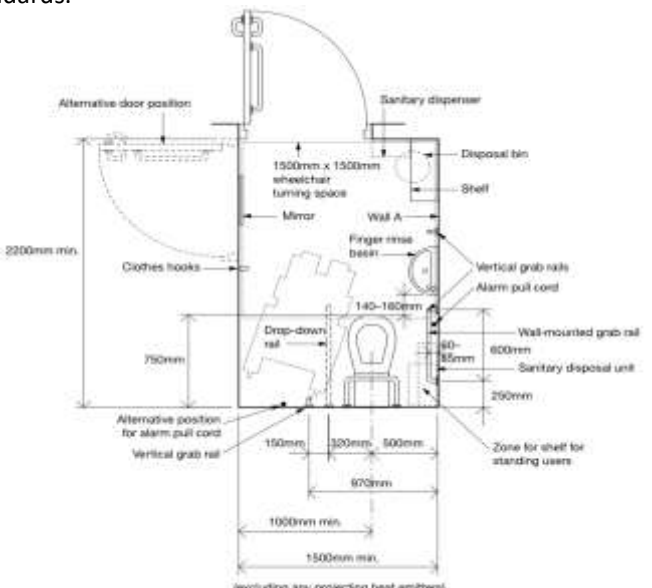
<p>13.1</p>	<p>A number of accessible facilities were identified across the school. Those identified were measured as follows: HK60.1, by the Hazelbeck entrance, 2475mm by 1430mm, which is marginally small. HK 55C, by the changing rooms, 1514mm by 2781mm HK57B, 2132mm by 2470mm, may be accessed with assistance. HK58B changing places with shower, 4980mm by 4150mm. HK58E first floor changing places 3950mm by 5090mm. HK57C 2245mm by 2400mm. HK57E 2067mm by 2422mm. HK58D 4880mm by 3870mm. HK60.3 2288mm by 1520mm HK60.2 1500mm by 2290mm Swimming Pool facility 1520mm by 2285mm</p>	<p>During future developments and proportionate to demand, the architectural feasibility of increasing the size of the accessible WC facility HK60.1 to ensure that it falls within the minimum ADM standards.</p>

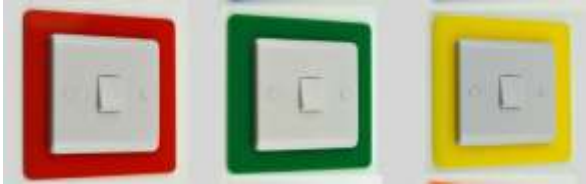
<p>16.2</p>	<p>Dimmer switches were identified to assist with gradually controlling light levels.</p> <p>Many of the light switch plates provided were white against a light background, which provides minimal contrast to assist people who are partially sighted.</p>	<p>At the next refurbishment for the sites, it would be beneficial to change the existing light switch plates with alternatives that have a grey/silver plate. This will ensure that they are easily located by people with impaired vision.</p> <p>All switches that require precise hand movement, such as light switches, thermostats etc, should be located between 750mm – 1200mm from floor level.</p>
